## Environmental Audit of the Sasol Mining Brandspruit Operations near Secunda, Mpumalanga Province`

### Compliance Audit Report

Sasol Mining Pty Ltd - Brandspruit Colliery

June 2022

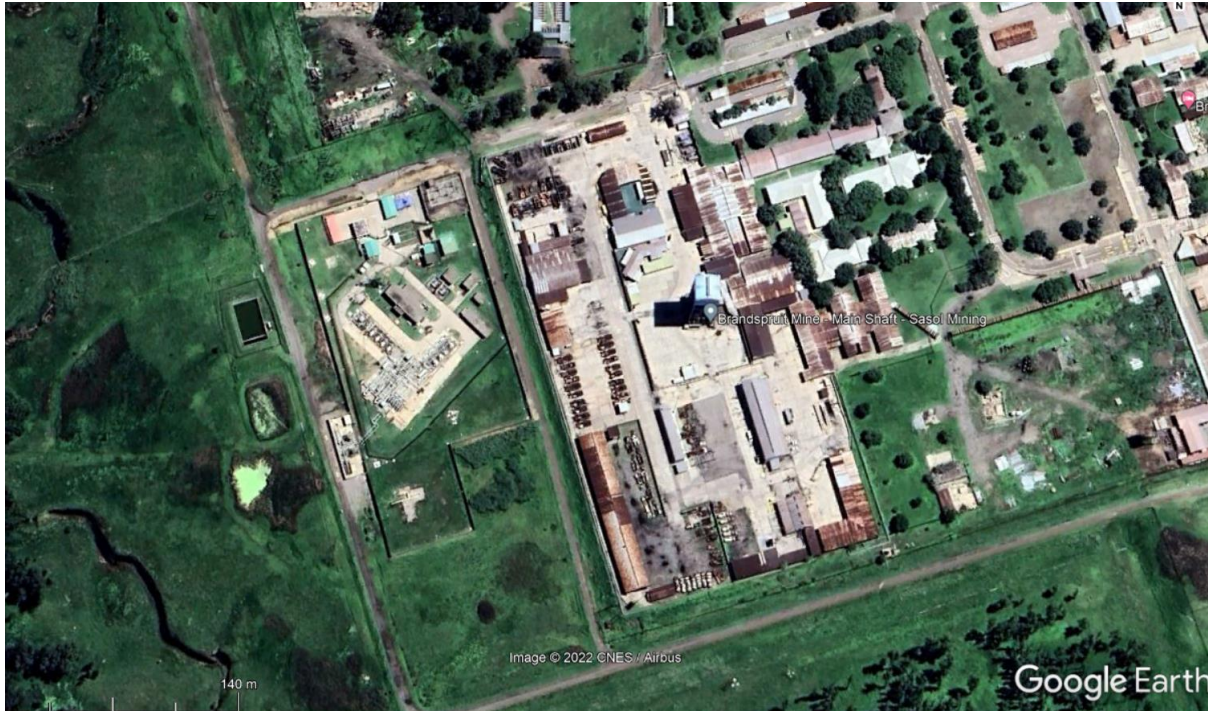
**Figure 10-1: Brandspruit Main Shaft**

The Brandspruit Main Shaft was backfilled with construction material and ash to prevent the accumulation of methane in the shaft void (Figure 10-1). The Shaft head gear has not been removed. At the time of the audit, it was noticed that all sorts of general waste was disposed of into the shaft (Figure 10-2) as a result of poor controls and housekeeping. The following observations were made at the time of the audit:

- No infrastructure has been removed from the site as part of the decommissioning and closure of the site;
- The bulk oil storage area containing the storage tanks is still in place, but is not currently in use and has not been rehabilitated;
- Administration buildings and office blocks are still in use by Engineering and Operational Services of Sasol Mining;
- The workshops are used to store and repair redundant and old machinery and equipment from other operational mines; and
- Good housekeeping was being implemented throughout the area.

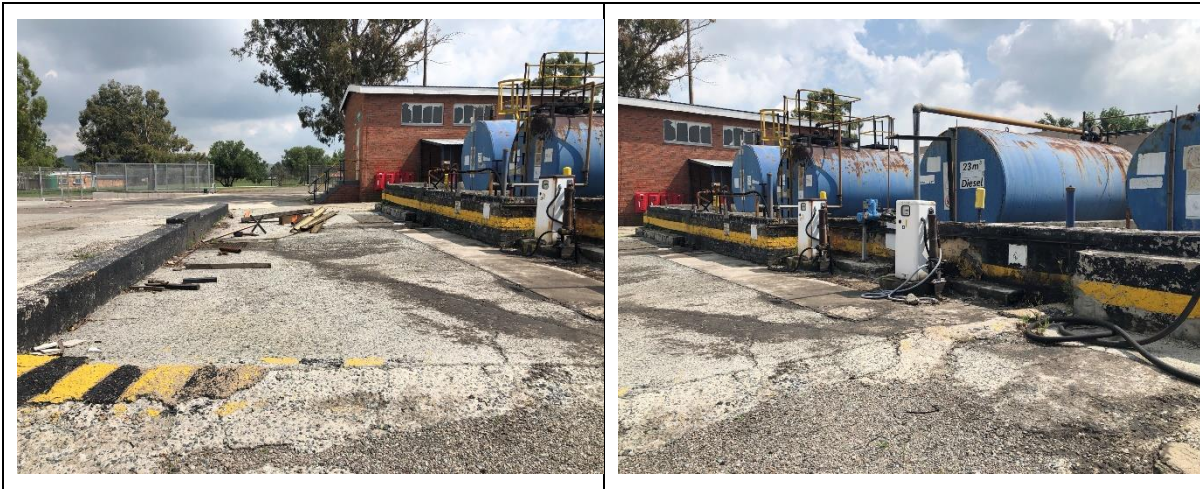
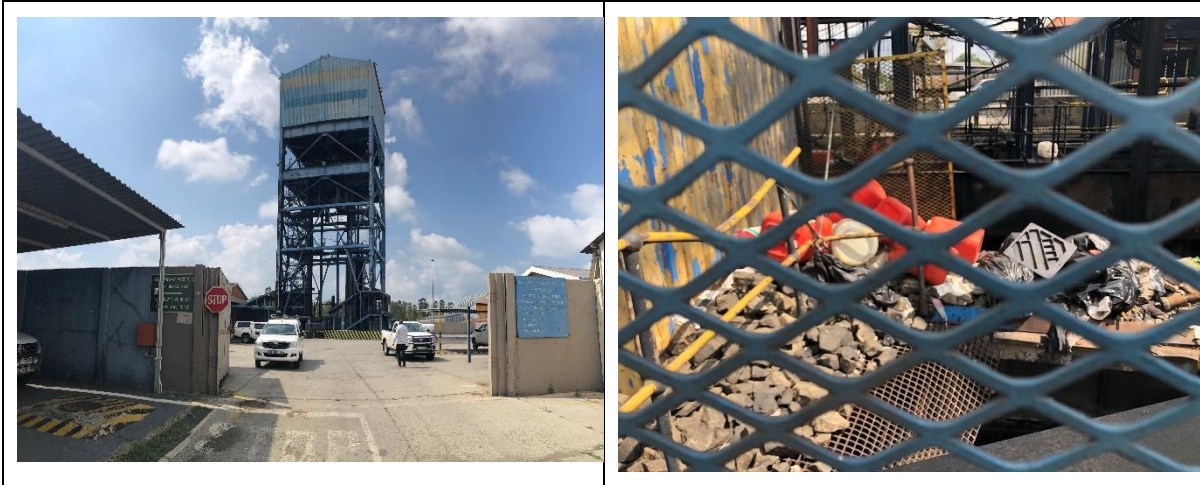
**Figure 10-2: Bulk Storage Tanks and Shaft at the Brandspruit Main Shaft**

Bulk oil storage tanks

Main shaft infrastructure

Builders Material backfilled into the shaft void

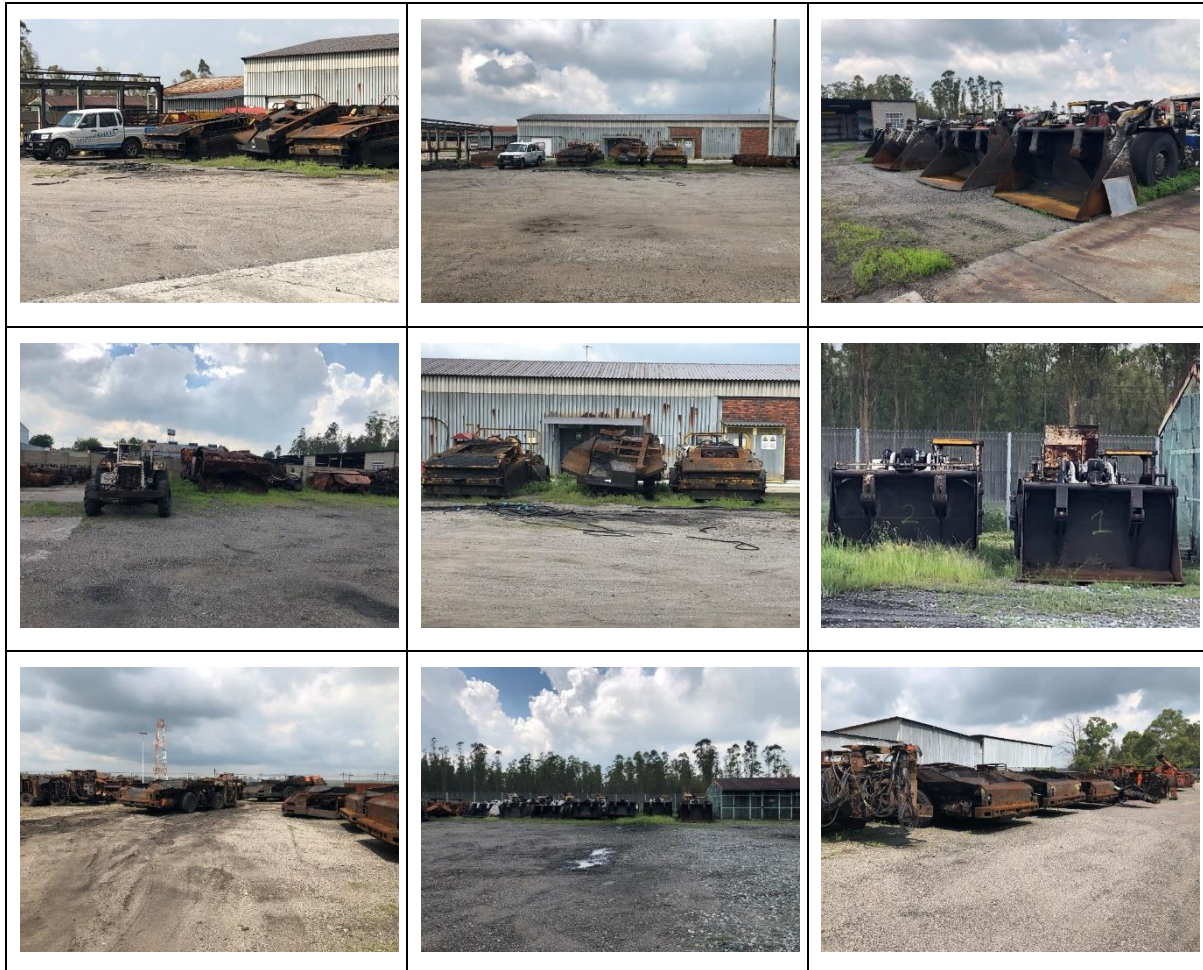
**Figure 10-3: Old and Redundant Equipment Stored at the Brandspruit Main Shaft**

The shaft area is also used for the storage of old equipment that is earmarked to be sold once it is removed from the mine's asset register. Due to the large number of machinery and equipment that needs to be stored, machinery and equipment is being stored in unpaved areas. In general, housekeeping in the area is commendable and the necessary spillage containment practices are in place.

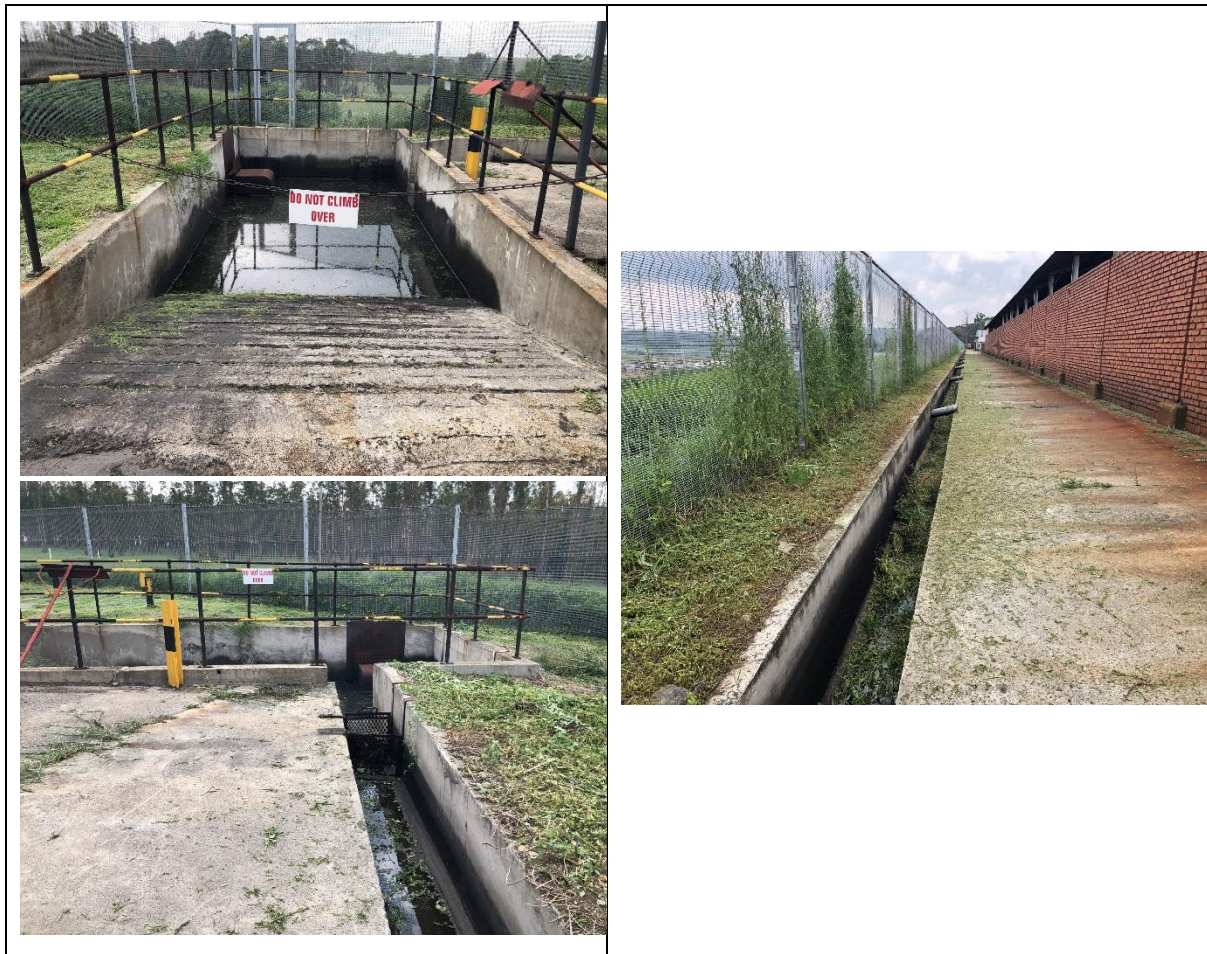
**Figure 10-4: Stormwater Trench and Sump at Main Shaft**

<p>Stormwater trench conveying contaminated water to the sump</p>	<p>Sump contains runoff from the surrounding area.</p>

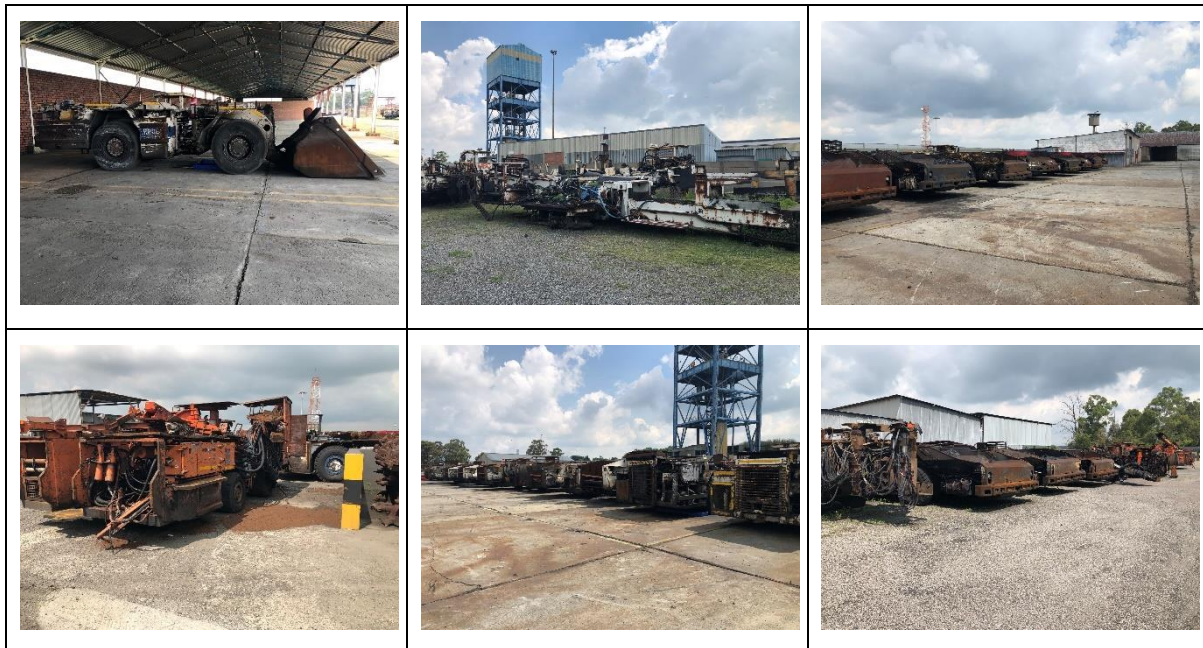
**Figure 10-5: Old Equipment Stored at Main Shaft**

Old equipment (Figure 10-5) that could not be used when Brandspruit mining operations moved to the Impumelelo Mine and other redundant equipment from the other mines are being stored at the Main Shaft. Due to the large number of equipment, it is necessary to store the equipment in unpaved areas. Some of the machines have been scrapped and removed from the mine's asset register and was numbered with spray paint.

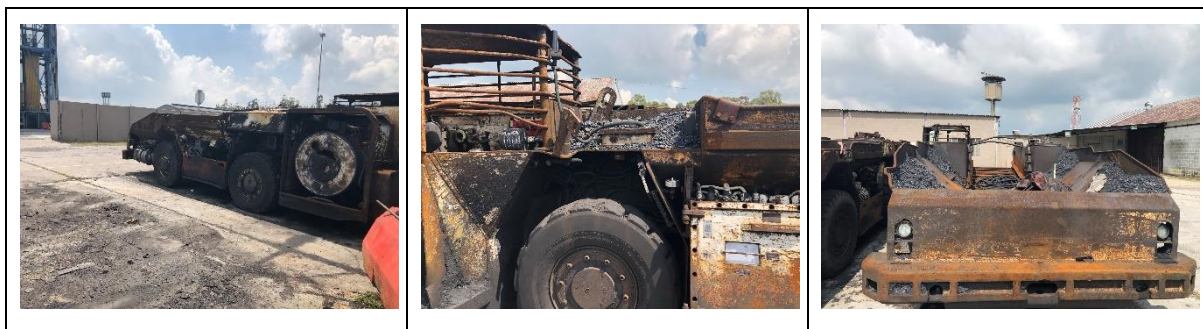
**Figure 10-6: Dirty Machinery Stored at the Main Shaft**

- Dirty machinery containing coal and fine coal are similarly stored within areas that are considered clean water areas. The machinery was leaking oil and this would result in the contamination of clean surface water runoff from the site; and

Dirty machines shown in Figure 10-6 were received from various other mines and were stored in this area, with no mitigation measures in place. This resulted in the material covering the machines being washed down during rainstorm events and contamination of surface water runoff. Machinery should not be transported to at stored at the Main Shaft if these are dirty.

- The Main Shaft Area and the Brandspruit Central Workshop must be managed in such a way that machinery is stored and parked within a dirty area;
- Machinery moved to the Main Shaft prior to the selling of the equipment must be cleaned from any fine coal or oil leaks to prevent the contamination of soil and potentially surface water runoff;
- The status of the heritage resources that have been undermined must be determined, should any of these be damaged and or impacted this must be addressed accordingly; and
- AIPs to be removed at Brandspruit No. 2 Shaft and where necessary, the area should be seeded with an indigenous seed mix applicable to the area.

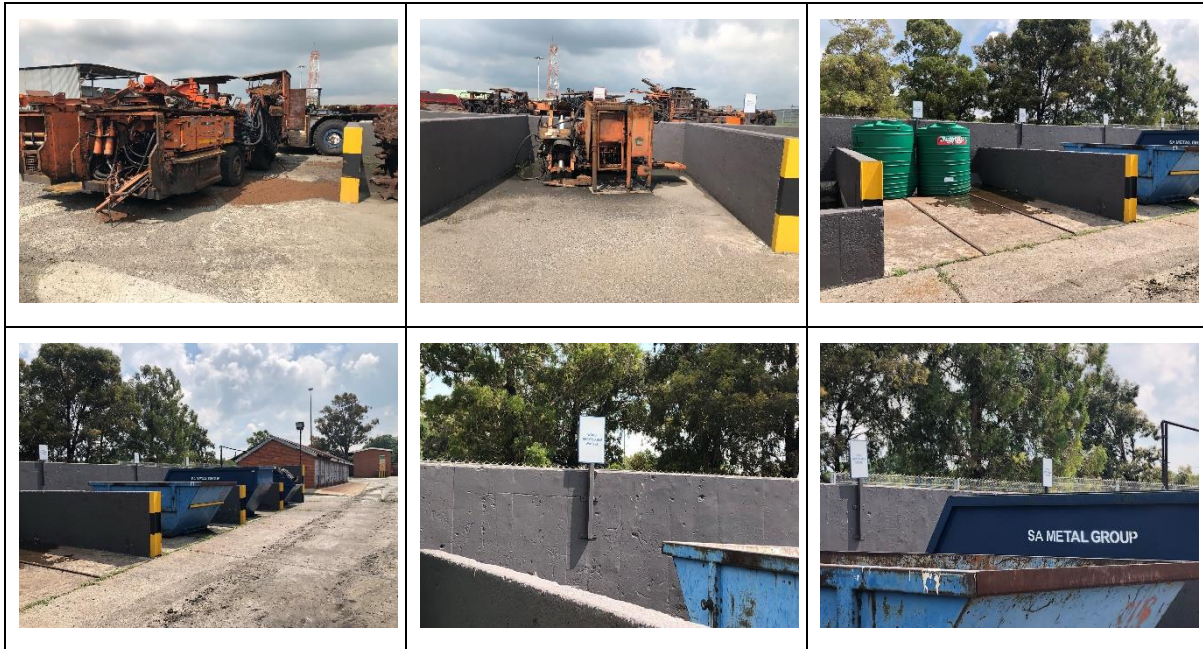
**Figure 10-7: Waste Management Area**

Although the Main Shaft is not operational with the exception of some of the workshops, the waste management area (shown in Figure 10-7) is well maintained and was upgraded after the 2019 Environmental Audit. Each waste stream is stored in an area which is labelled and demarcated for each of the specific wastes streams.

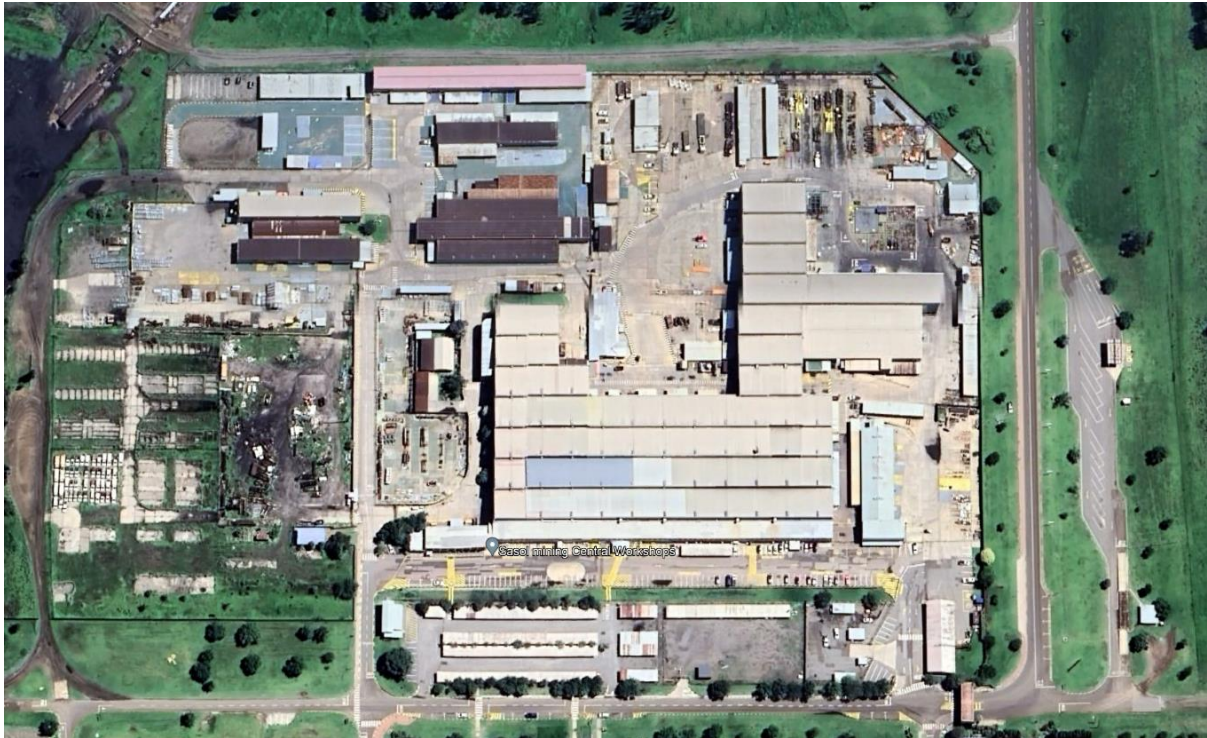
**Figure 10-8: Brandspruit Central Workshop**

Engineering Services (ESS) shown in Figure 10-8 are responsible for operating and managing the Central Workshops within the Sasol Mining Complex. The Central Workshop is used to repair machinery from Sasol Mining operations, where these services are not available on the mines. Various workshops are used to maintain machinery, e.g., painting booth, boiler workshop, etc. In general, the housekeeping is of a very high standard and people are dedicated to cleaning of spillages. The EMPr requires that spillages be cleaned as soon as possible. Evidence was found at the time of the site visit that employees attend to spillages as soon as possible.

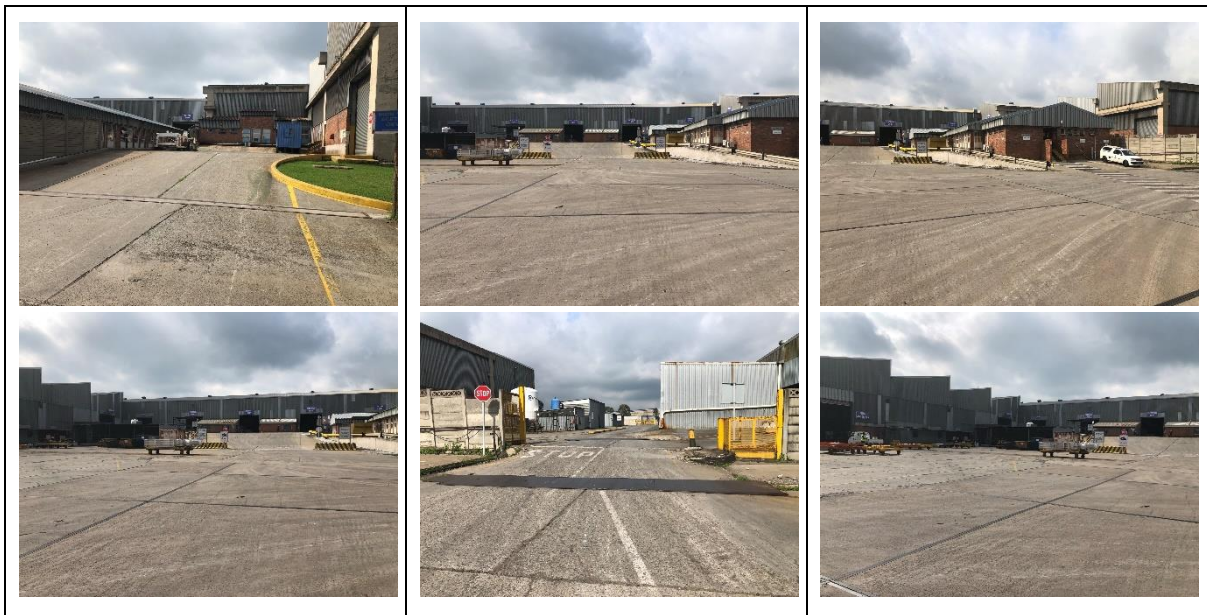
**Figure 10-9: Central Workshop**

The infrastructure at the Central Workshops comprise of workshops, concreted and paved parking areas, a sump collecting water from the wash bay and a waste storage area, as shown in Figure 10-9.

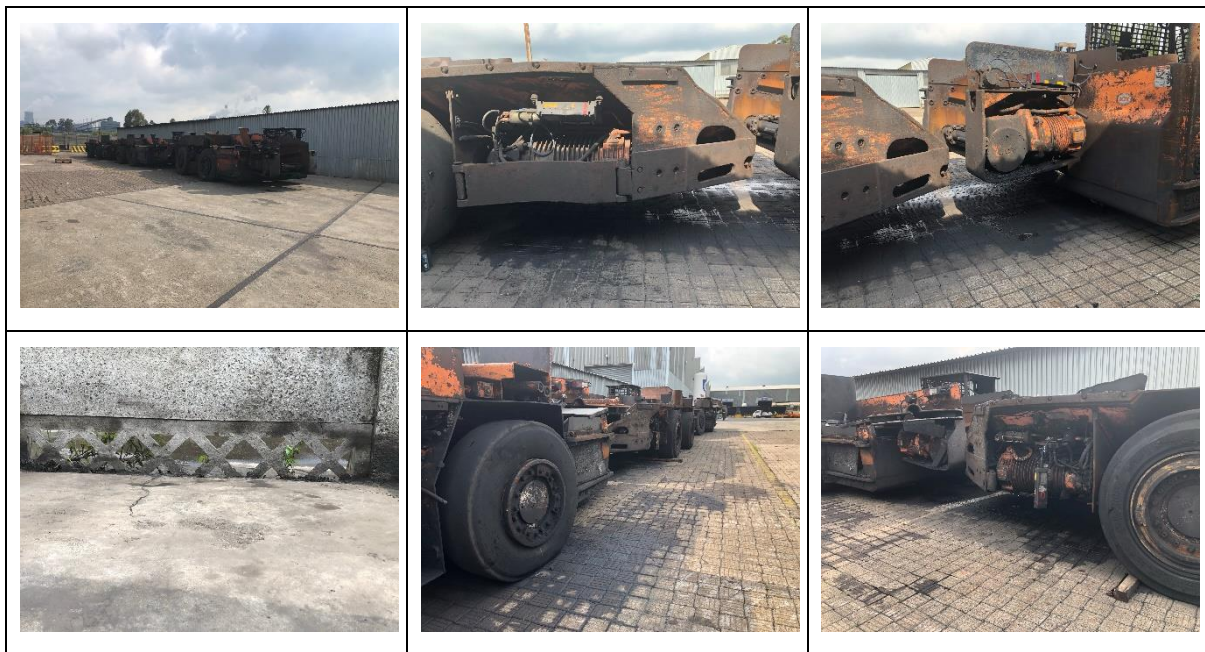
**Figure 10-10: Machines Requiring Repairs Stored in Clean Area**

- Stormwater management:
  - No clear separation of clean and dirty stormwater management was found at the Brandspruit Central Workshop. At the time of the site visit, it was found that machinery requiring repairs were parked and stored in the clean water area, thus increasing the dirty water area's footprint. This resulted in the contamination of soil and surface runoff from this area and potential run-off of dirty water into the environment;

There is no clear separation of clean and dirty stormwater at the Central Workshop. Due to the challenge of not being able to contain contaminated runoff to the immediate area from the Central Workshop, the area is managed by cleaning any spillages as soon as it happens. All spillages are cleaned immediately and disposed of according to the Standard Operating Procedure (SOP). At the time of the audit, it was noticed that two machines (shuttle cars) that required repairs were parked in an area that was demarcated as a clean water area. As indicated in Figure 10-10, these machines were leaking oil and the necessary drip trays were not used to contain oil leaks. The potential therefore exist that surface runoff can be contaminated by hydrocarbons and will flow into the environment through the outflow shown in Figure 10-10.

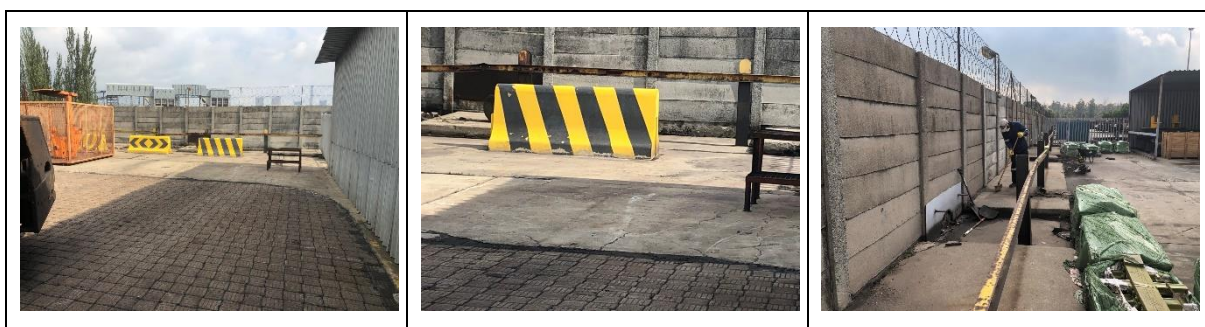
**Figure 10-11: Steel Plates Used to Seal the Outflows in the Wall**

In an attempt to manage stormwater on site, the outflows in the walls were sealed with steel plates and spill sorb socks and mattresses; and booms were placed in front of these steel plates to contain any hydrocarbon contamination. Refer to Figure 10-11.

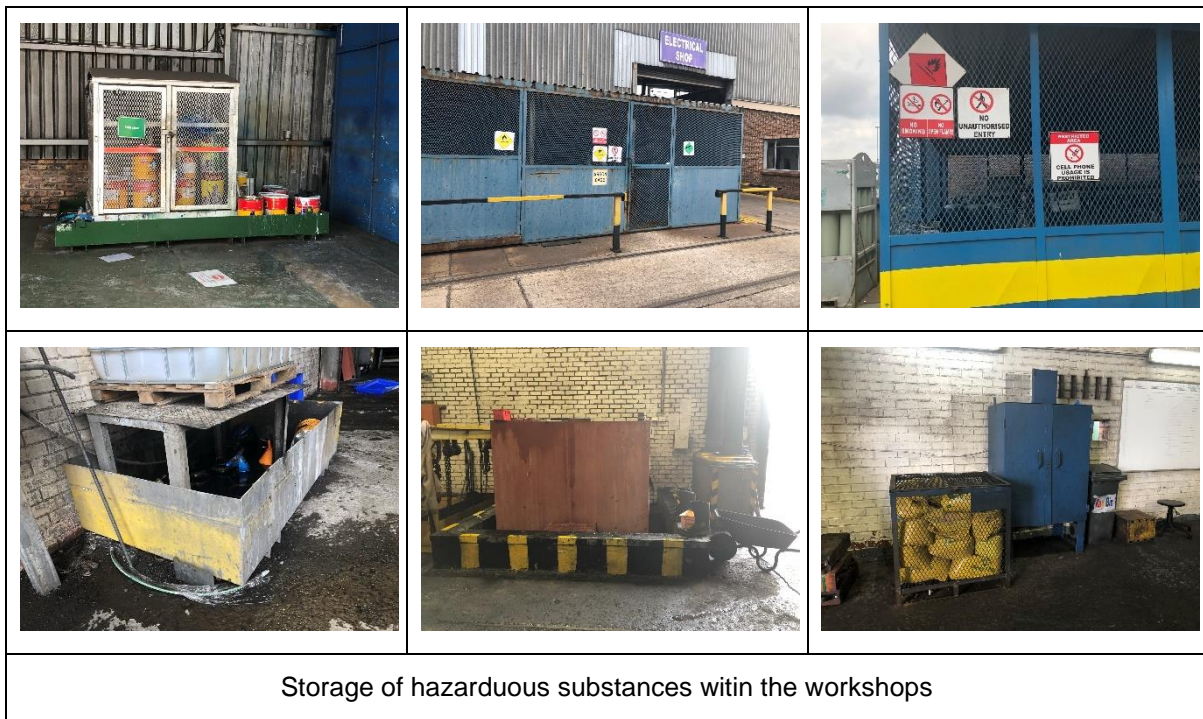
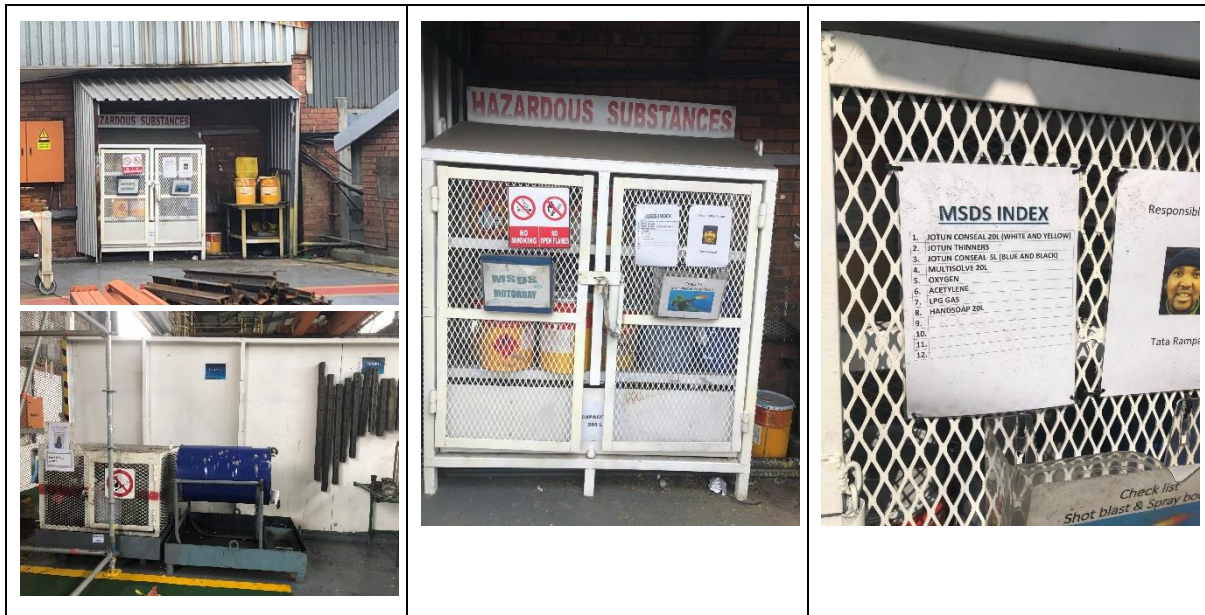
**Figure 10-12: Storage of Hazardous Substances**

Hazardous substances are stored in an allocated area within each of the workshops and paint booths shown in Figure 10-12. These substances are stored in a lockable, bunded store with the Material Safety Data Sheet (MSDS) readily available. However, it is recommended that the MSDS file are reviewed to ensure the correct MSDS for a specific product is included.

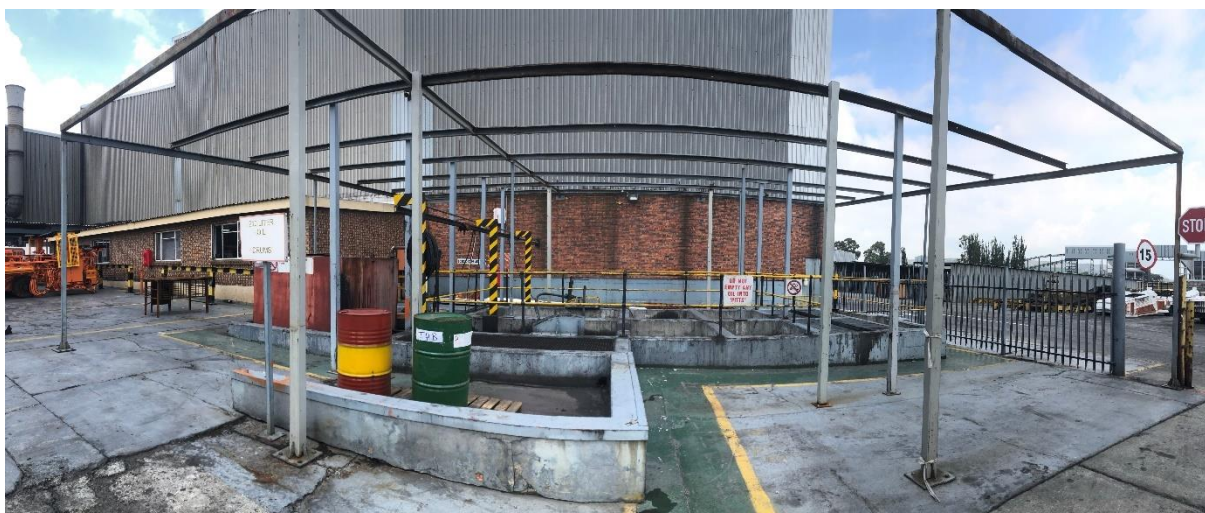
**Figure 10-13: Oil Separator**

All wash water from the wash bay is directed to the central oil separator (Figure 10-13). This oil separator is not functioning optimally and the Environmental Practitioner was in discussion with a number of service providers at the time of the audit to determine the best way forward. The separator's capacity is not sufficient to manage all the water generated at the wash bay. The final sump is cleaned out as and when required by a service provider. The waste is then disposed of to an appropriate licenced landfill facility. The old oil is recovered and is removed from site by a service provider. The Safe Disposal Certificates for this was made available.

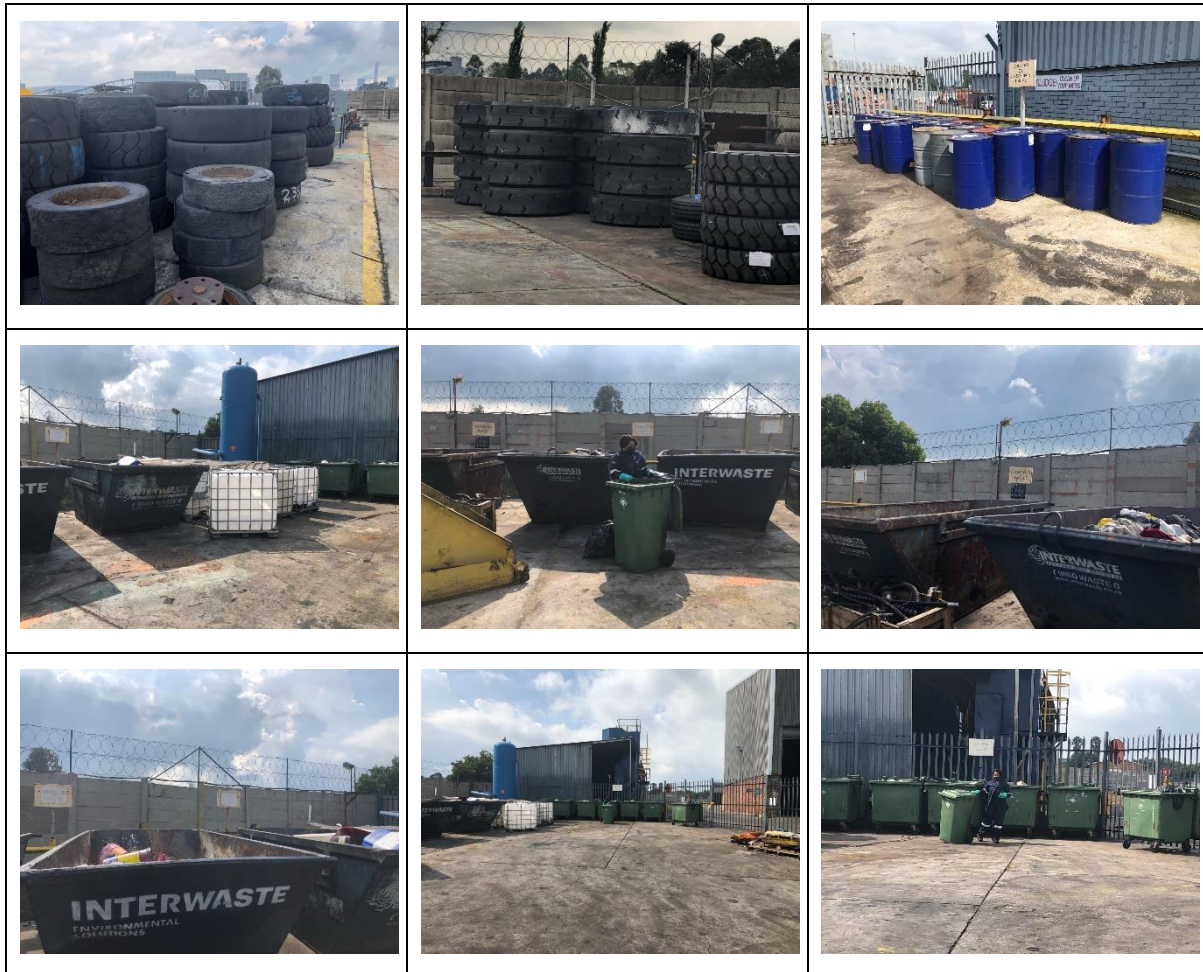
**Figure 10-14: Brandspruit Central Workshop Waste Management Area**

Figure 10-14 shows that good waste management practices are implemented at the Central Workshop. Waste is removed and disposed of to a central waste management area. The area is clearly demarcated for the various waste streams. A service provider is appointed to remove the hazardous waste and old oil. General waste is removed by Sasol Reclamation and disposed to the Charlie 1 landfill site.

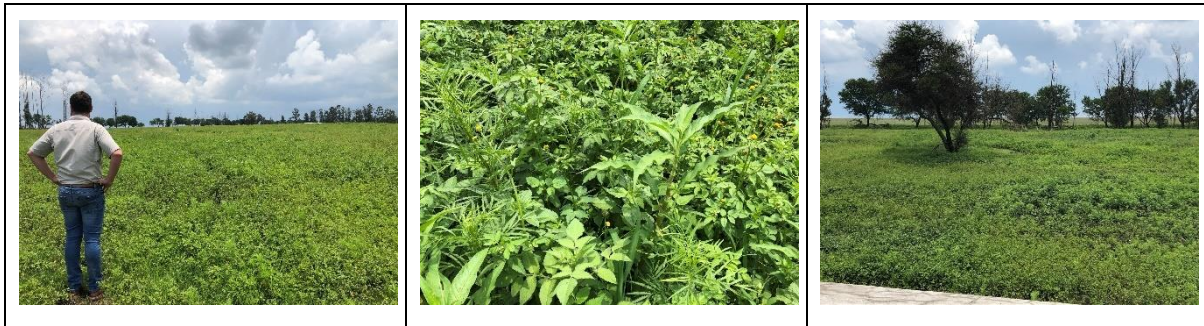
**Figure 10-15: Brandspruit No. 2 Shaft**

- Monitoring of rehabilitated areas and management of Alien Invasive Plants:
  - No information was made available that the Brandspruit No. 2 Shaft was monitored for establishment of AIP species on a regular basis after it was rehabilitated. At the time of the audit, it was found that weeds and AIPs were found to be the dominant species occurring in the area. Natural vegetation has not been successfully established at the time of the audit.

Although the area shown in Figure 10-15 was vegetated, the following actions were not successfully completed:

- Although vegetation was established, the vegetation was not characteristic of local indigenous vegetation, but comprised of weeds and AIP species. Thus the re-establishment of vegetation within the previously utilised land use areas was not successful; and
- No proof of continuous monitoring and auditing of rehabilitation was available at the time of the audit to ensure that rehabilitation is sufficiently successful.

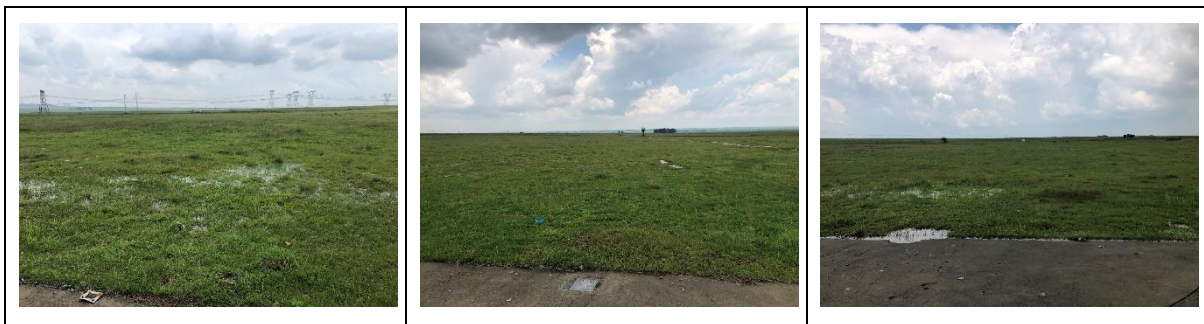
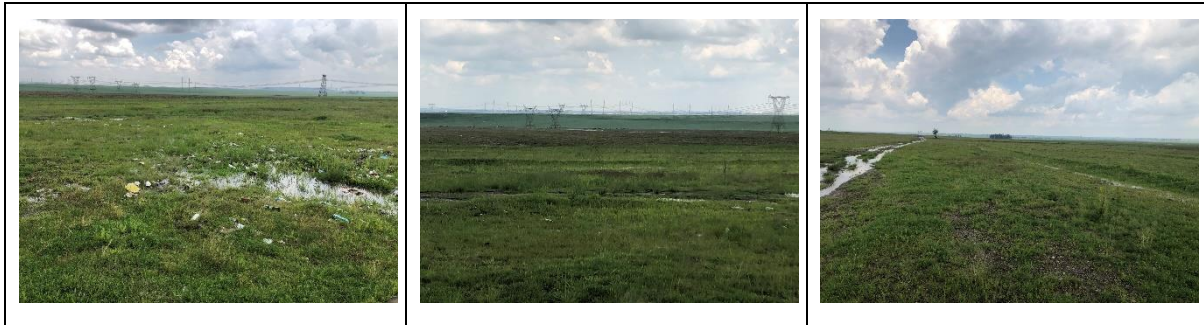
**Figure 10-16: Brandspruit No. 3E Shaft**

Figure 10-16 shows that Brandspruit No. 3 E Shaft has been closed and rehabilitated. This property has also been sold to a third party. All rehabilitation was completed and maintenance was undertaken to address erosion and AIP proliferation.
