**SASOL MINING (PTY) LTD**  
**Twistdraai Colliery Thubelisha Shaft**

**EXTERNAL AUDIT: ENVIRONMENTAL AUTHORISATION  
& ENVIRONMENTAL MANAGEMENT PROGRAMME**

**DECEMBER 2022**

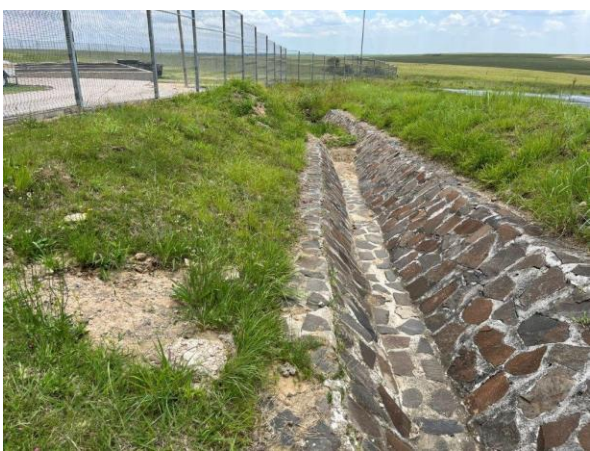
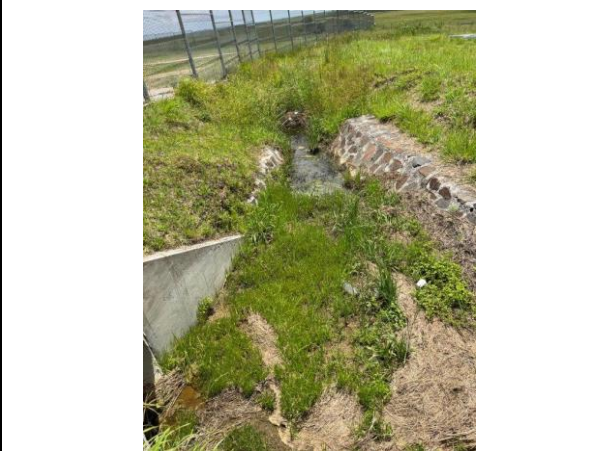
It was noted during the audit that sections of the water management canals have dense reed growth and vegetation (grass). The vegetation restricts the flow of water and encourage siltation, decreasing the capacity of the canal and increasing the risk of uncontrolled spills.

<p>Silted stormwater canal system</p>	<p>Silted stormwater canal systems</p>

As part of the final EMP for Thubilisha, it was committed by the Mine that clean water will be diverted away from the dirty water areas and permitted to discharge into the Debeerspruit and natural environment. The mine also committed to cleaning the stormwater canals regularly to prevent blockages and allow the water to naturally flow away from the mine.

- Continue to address fugitive dust exceedances and ensure compliance with NAEIS.
- Implement regular maintenance of all stormwater (clean and dirty) systems at all areas on the Mine, including seepage control at the coal emergency / throw out stockpile area.
- Update the underground mining planned model and the approach to address the requirements of the EMPr.
- Establish a functioning security group within surrounding farmers.
- Develop a Conservation Management Plan.
- Initiate public awareness programmes regarding subsidence.

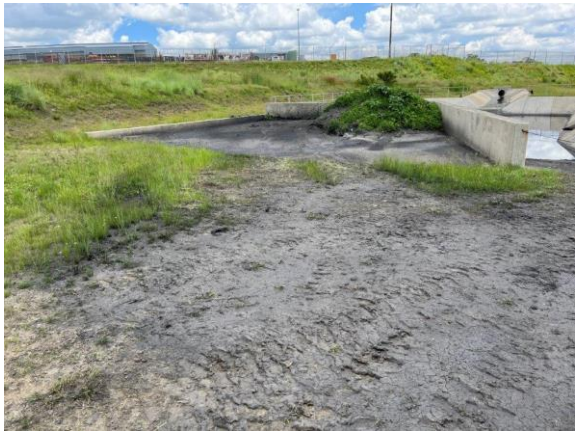
The sediment cleaning areas encroaches into the clean water canal running past this facility. During cleaning events contaminated runoff enters the clean storm water system, as shown in the photographic evidence below.

<p>Sedimentation ponds storage area that encroaches onto clean stormwater canal system</p>	<p>Coal spillages into clean stormwater canal system</p>
