Establishment of Ethylene Purification Unit /EPU 5) Facility– ref (EMS/1/(e)/08/32)

EPU5 ENVIRONMENTAL AUTHORISATION (REFERENCE: EMS/1(E)/08/32) AND ENVIRONMENTAL MANAGEMENT PROGRAMME

Audit Report: November 2019 - January 2023

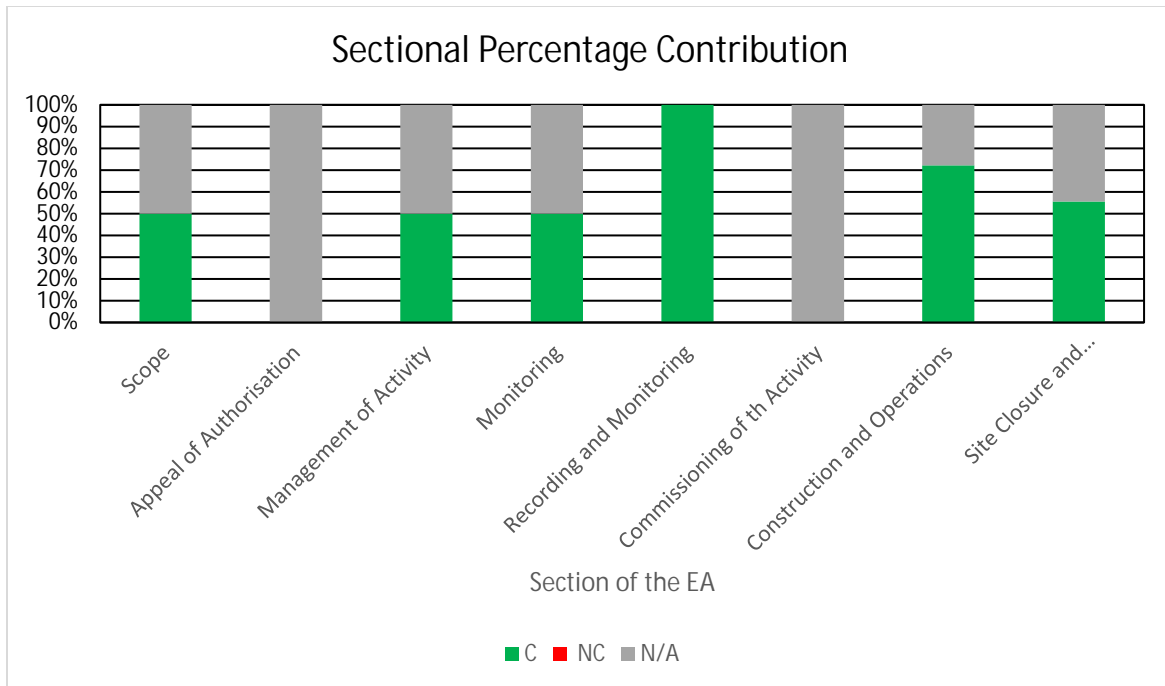
Figure 6-3 - Percentage contribution of findings made to the EA Commitments per Section

Figure 6-3 illustrates the percentage contribution of the findings of the EA commitments and **Figure 6-4** presents the total percentage compliance for the facility.
