ENVIRONMENTAL AUTHORISATION EXTERNAL REPORT SUBMISSION

Upgrading SASCON road facility, Construction of OSB– ref [EM1/1(c)00/30]

**ROAD LOADING FACILITY AND NEW OIL
SEPERATION BASIN (OSB) ENVIRONMENTAL
AUTHORISATION (REF. NO: EM1/1(C)/00/30)
AND ENVIRONMENTAL MANAGEMENT
PROGRAMME AUDIT**

Compliance Audit Report: November 2024 - July
2024

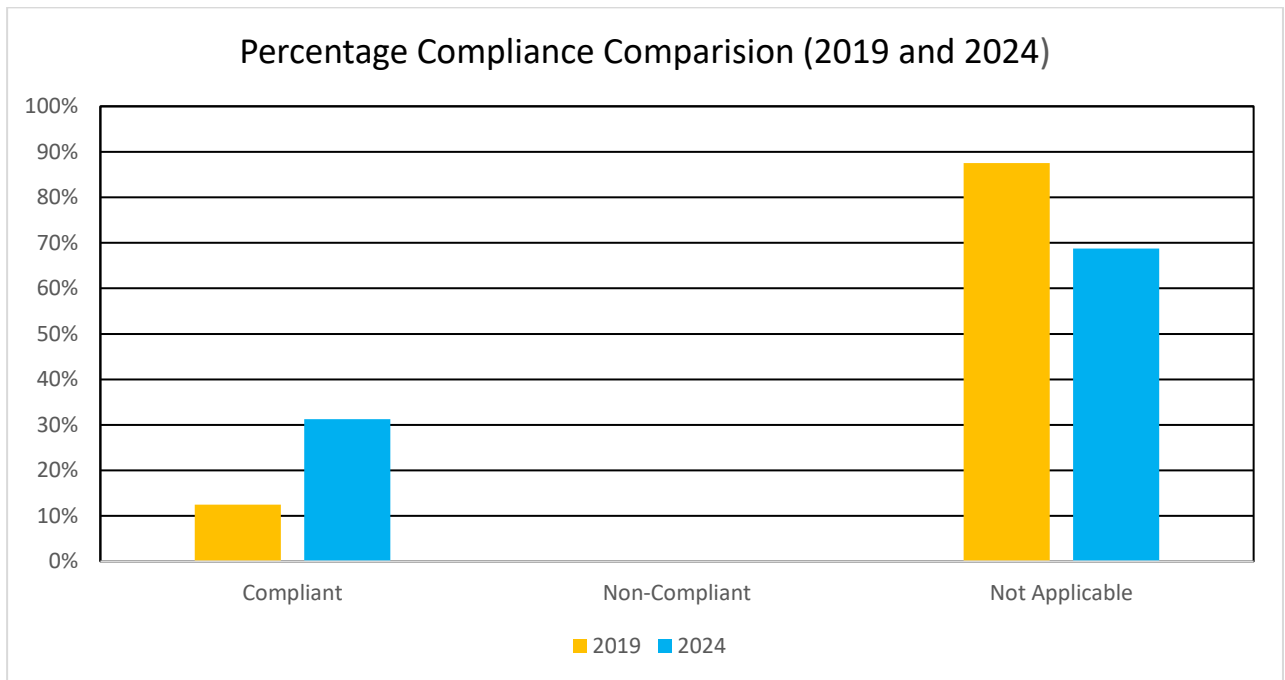
Figure 5-1 – Percentage comparison of Environmental Authorisation compliance levels from 2019 to 2022

The previous EA and EMPr compliance audit report was compiled by the Northwest University CEM in 2019. A comparison in the change of compliance rating between the 2019 and 2024 audits are provided in **Figure 5-1** and Error! Reference source not found. below, and provides a summary of the audit findings for the previous and current audits (2019 and 2024). The 2019 audit identified zero non-compliant conditions.

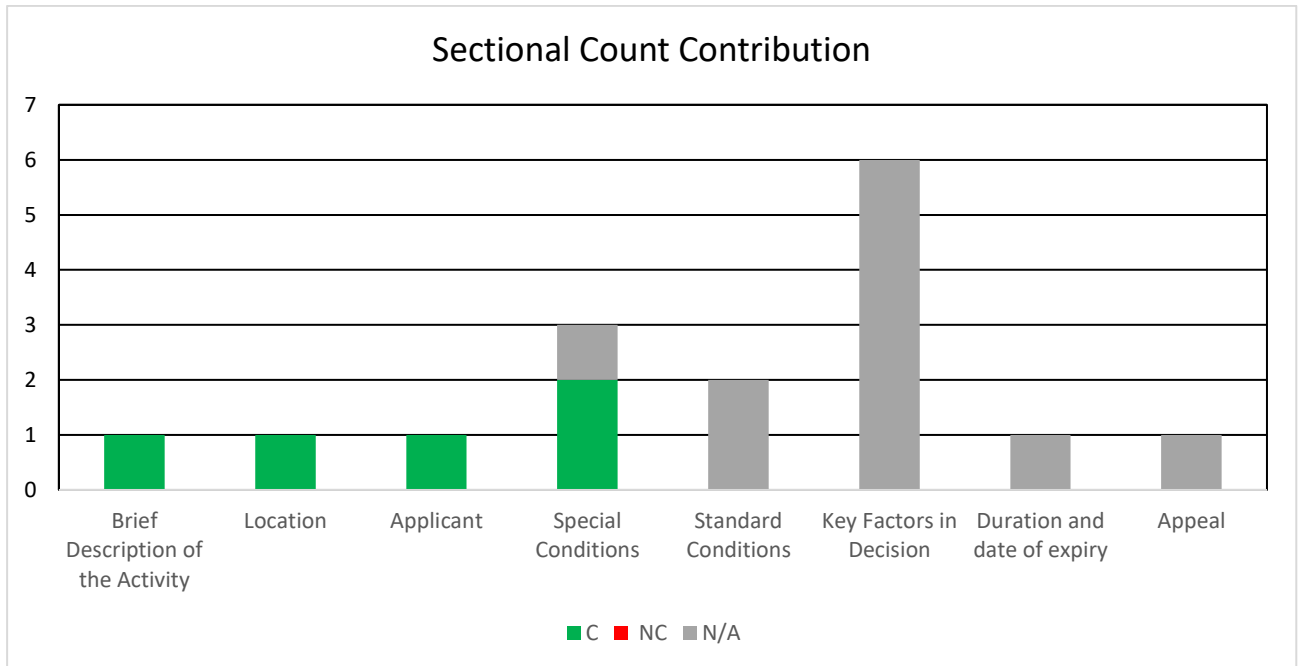
Figure 6-1 - Number/Count contribution of findings made to the EA conditions per section

Figure 6-1 illustrates the number/count contribution of the findings of the EA conditions per section while **Figure 6-2** presents the total proportion of compliance for the EA.

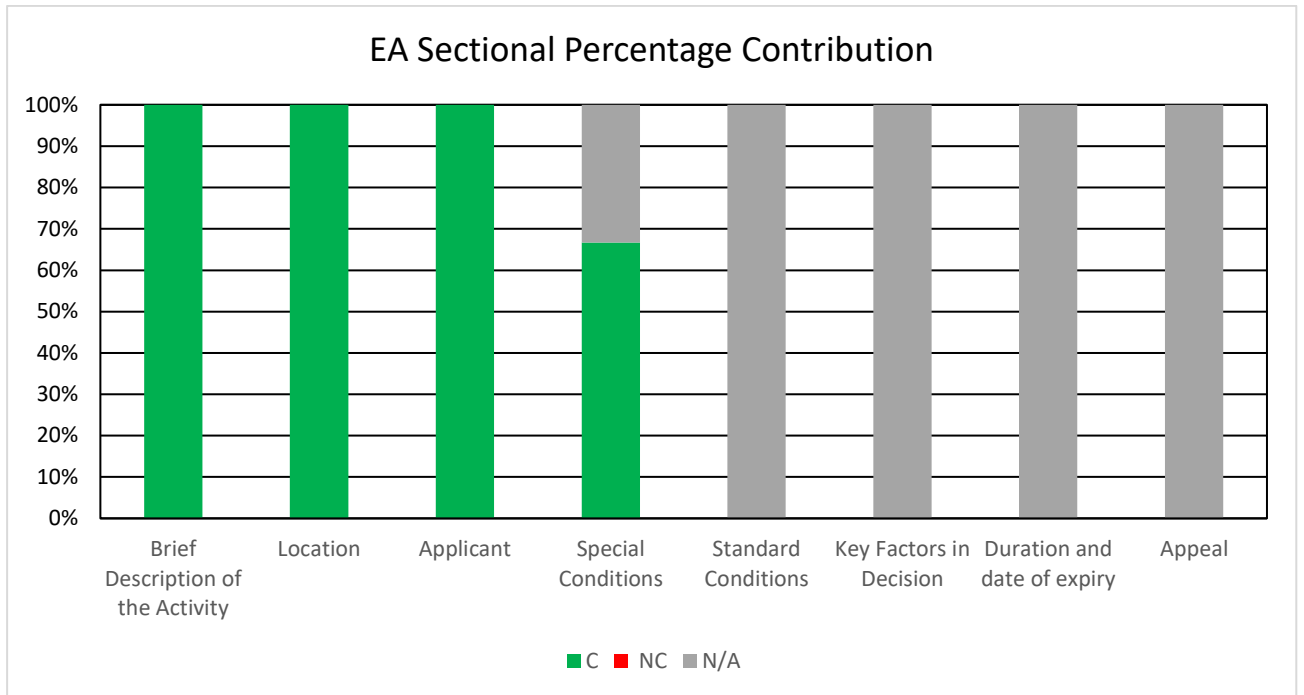
Figure 6-3 - Percentage contribution of findings made to the EA Commitments per Section

Figure 6-3 illustrates the percentage contribution of the findings of the EA commitments and **Figure 6-4** presents the total percentage compliance for the facility.

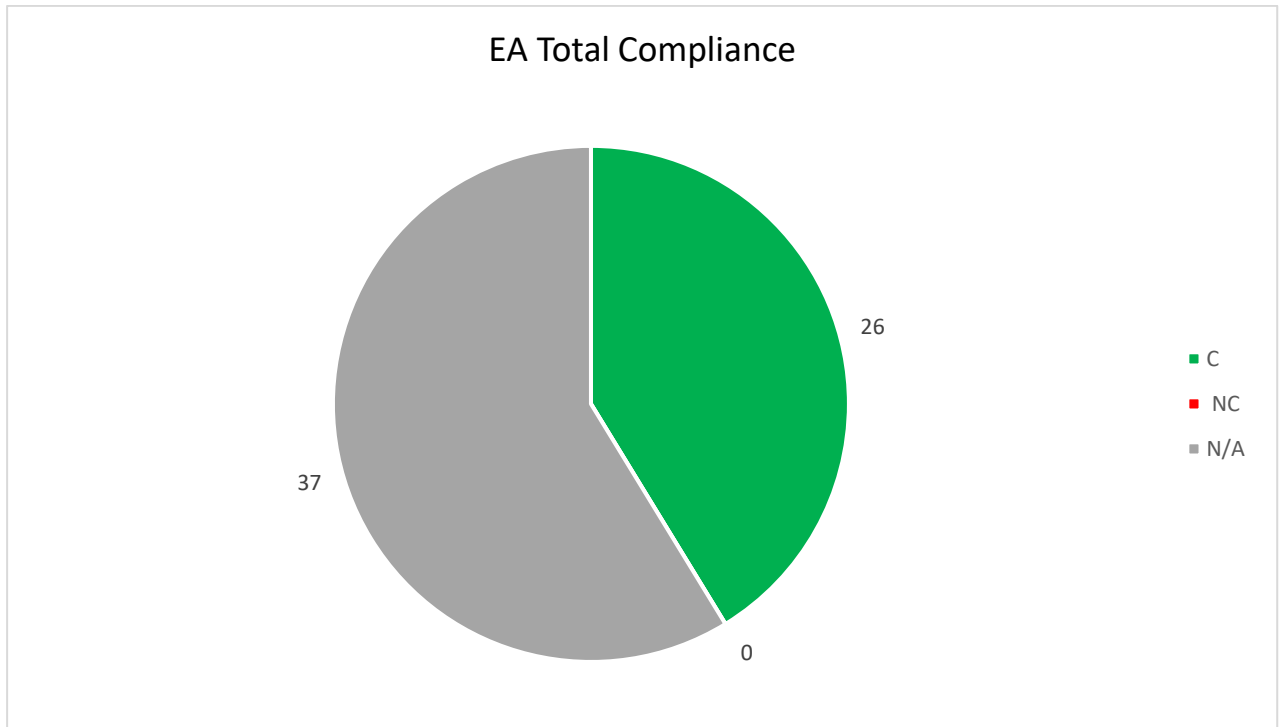
Figure 6-5 - Overall count findings on compliance to the EMPr Commitments

Figure 6-5 presents the total proportion of compliance for the facility and **Figure 6-6** illustrates the number/count contribution of the findings of the EMPr per section.

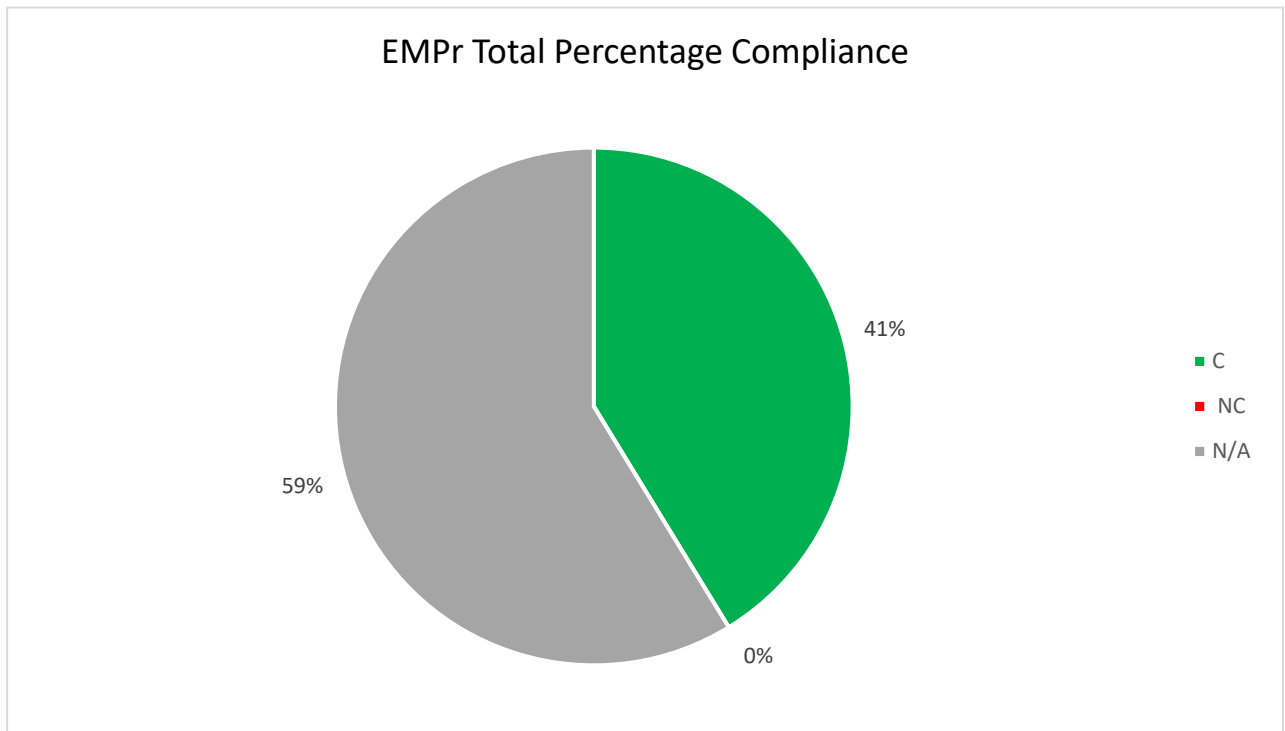
Figure 6-7 - Overall percentage findings on compliance to the EMPr Commitments

Figure 6-7 presents the total percentage compliance for the facility and **Figure 6-8** illustrates the percentage contribution of the findings of the EMPr commitments.
